TENSILE TEST OF CORED REPAIR MATERIAL FROM NEWPORT BRIDGE PIERS

October 2004

Prepared for the Rhode Island Turnpike and Bridge Authority
by:

Michael Sock
Research and Technology
Rhode Island Department of Transportation

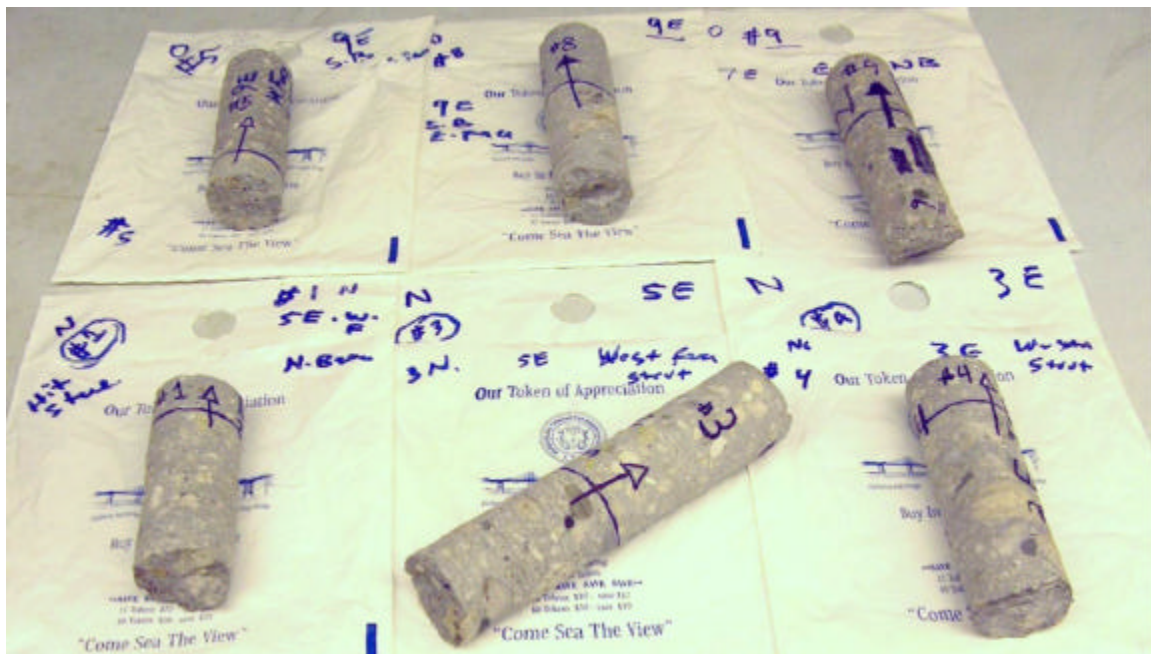
Figure 1 – Test Specimen Cores

The specimens were received from RITBA and photographed (Figures 1, 3 through 9). RITBA did not identify which specimens were from the suspect areas, to prevent any bias being developed by the individuals performing the testing. The repair material had been placed six to eight weeks earlier and had therefore cured well in excess of 28 days prior to testing. The arrow indicates the top of the core and the line around the circumference indicates what was considered to be the interface between the substrate and the patch. The specimen characteristics were then recorded (see Initial Observations). The specimens were trimmed on each end, to create a cylinder with parallel ends perpendicular to the long axis of the cores, after which they were photographed again (Figure 2).

All cores were 1.75 inches in diameter, with the repair mortar a darker gray than in the original concrete. There was no visible discrete boundary between the patch and the substrate, indicating that there was no delamination even after coring and removal. The top surface of the cores showed a wood grain pattern, indicating that the repairs were of the form and place method. Notes for the individual cores (prior to any preparatory work) are as follows:

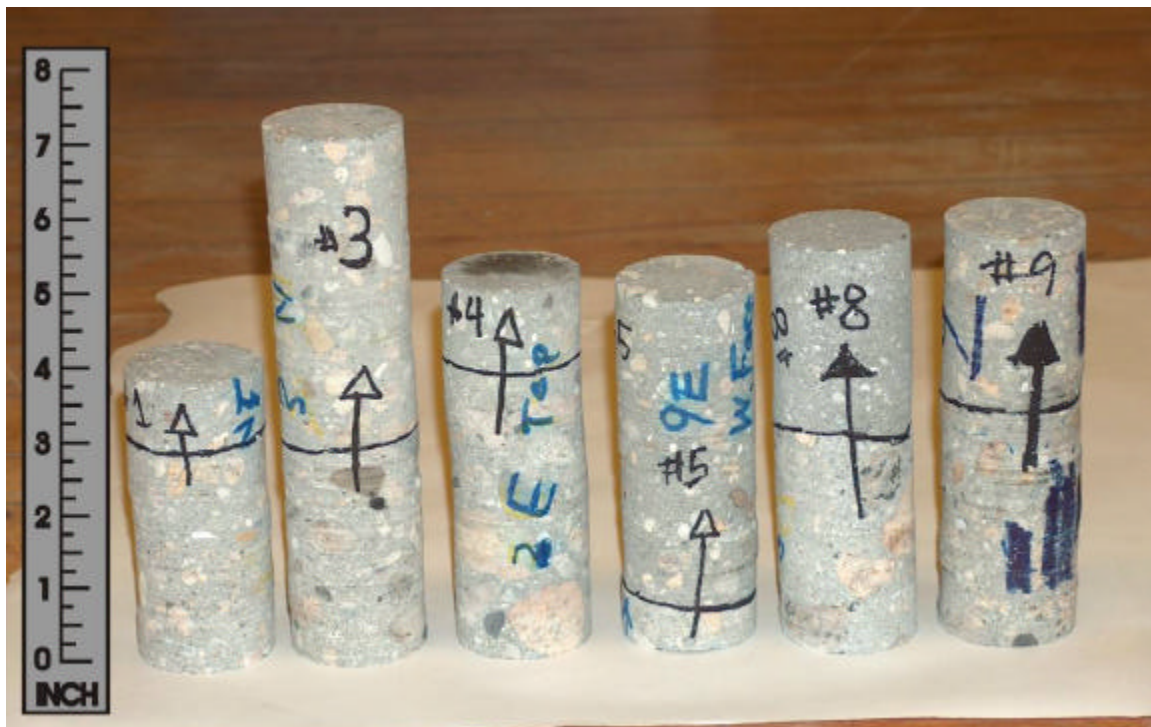
Figure 2 – Test Specimen Cores After Cutting to Square

Because there was substantial variability in the cores, they were not cut to a uniform length. Trying to use a fixed aspect ratio would have created inconsistent properties for the specimens (patch to substrate thickness, aggregate size to matrix thickness), which would have eliminated any advantage in having the same length for all specimens. Note that the repair material/substrate interface was not typically a flat plane perpendicular to the axis⁷. These variables had the potential to add some complexity to the analysis of the results.

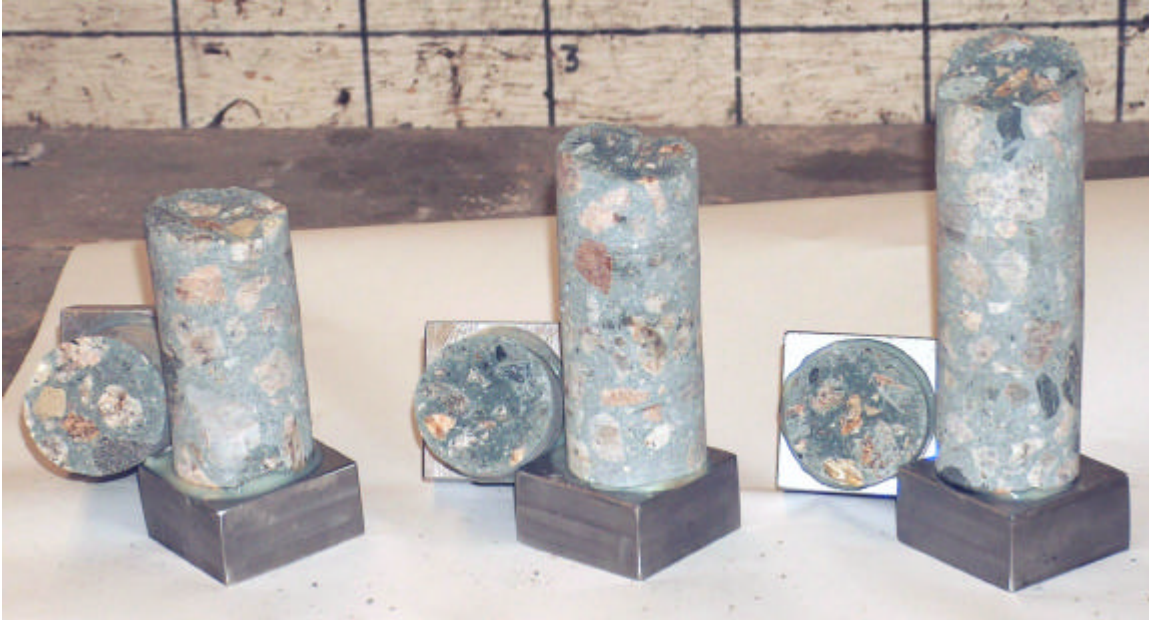
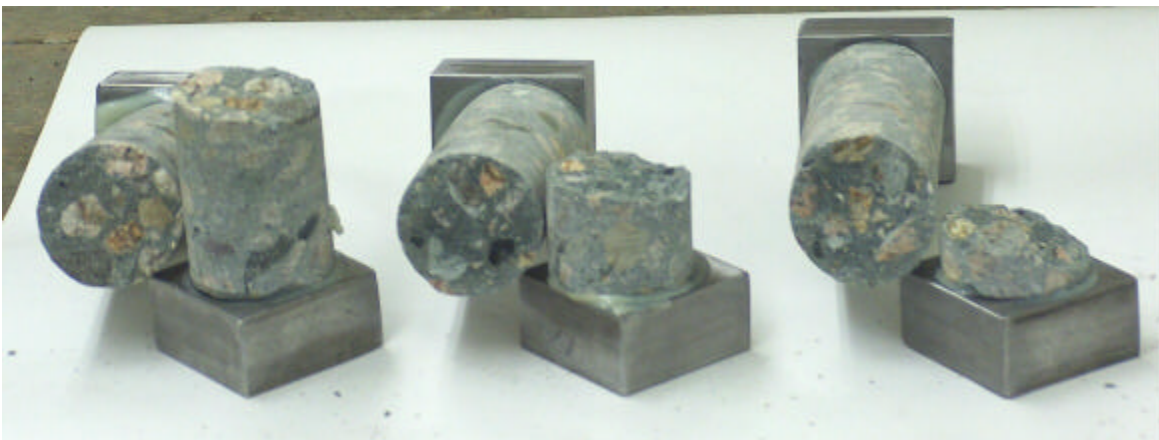
Figure 15 – Top Photo: Fracture Faces of Preliminary Specimens, Bottom End Upright;
Bottom Photo: Fracture Faces of Preliminary Specimens, Top End Upright

Prior to testing the RITBA samples, a spare untested compression cylinder³ was cored to create specimens to check the setup of the apparatus and confirm that the adhesive⁴ was adequate for the application. Three samples were created and cut square on each end. The specimens were then bonded to the plates. Special care was taken make certain that the assembly was aligned such that it would load through and parallel to the longitudinal axis of the cores (Figures 10 through 12). The specimens were loaded using the method as described above and the failure mode indicated that the system would provide accurate results. The machine was set to the low range of 1,800 pounds force. The failures ranged from 500 to 1040 pounds (208 psi to 432 psi), somewhat lower than expected⁵, but all of the breaks occurred in the concrete, not the epoxy. The lower breaks may have been due in part to the loading rate. Based on the rates used for these specimens, it was decided that a maximum rate of 250 pounds/minute would used for the RITBA cores. This was considered sufficiently slow to avoid a high rate of strain and shock loading the concrete to premature failure. Photos of the fracture faces of the specimens can be seen in Figure 15.
